APPENDIX B

Conceptual Architectural Rehabilitation

Clinton Street District Revitalization
1 Clinton Street
Village of Brockport, New York

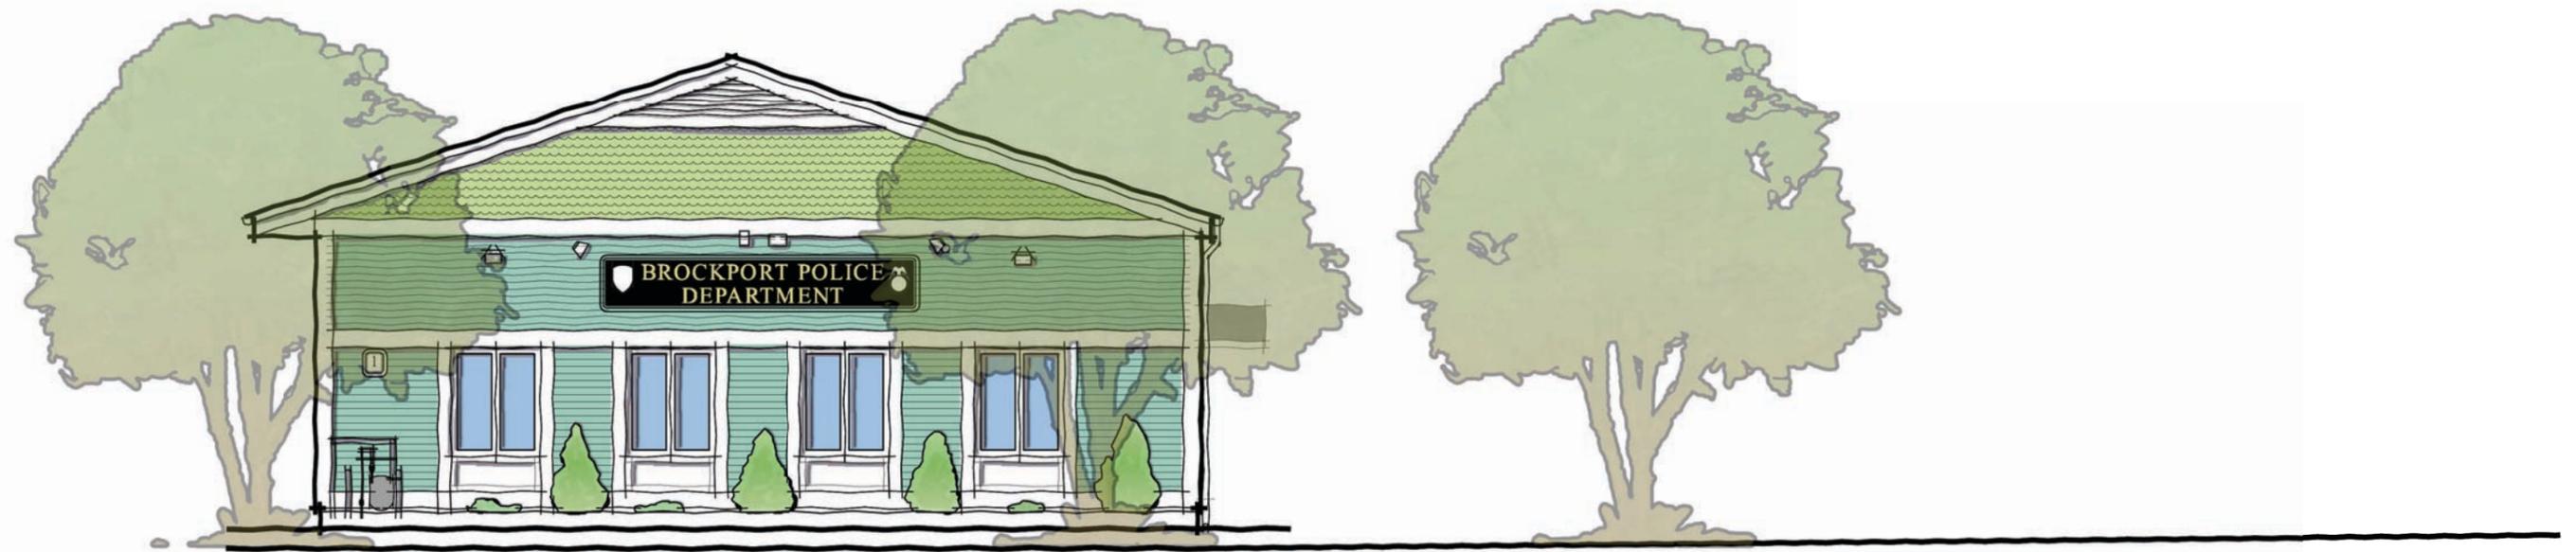
1 Clinton Street

1. One story building.
2. Front facing gable, moderate slope roof.
3. Simple rectangular plan.
4. Four bays, no entrance at front elevation.
5. Horizontal artificial siding.
6. Paired casement windows.

1. Provide wooden trim and gable louver.
2. Provide pedestrian walk and green space on entry side.
3. Provide landscaping to separate parking lot from street, provide street trees.
4. Paint rusty utility piping.
5. Reconfigure parking area as shown on site plan.

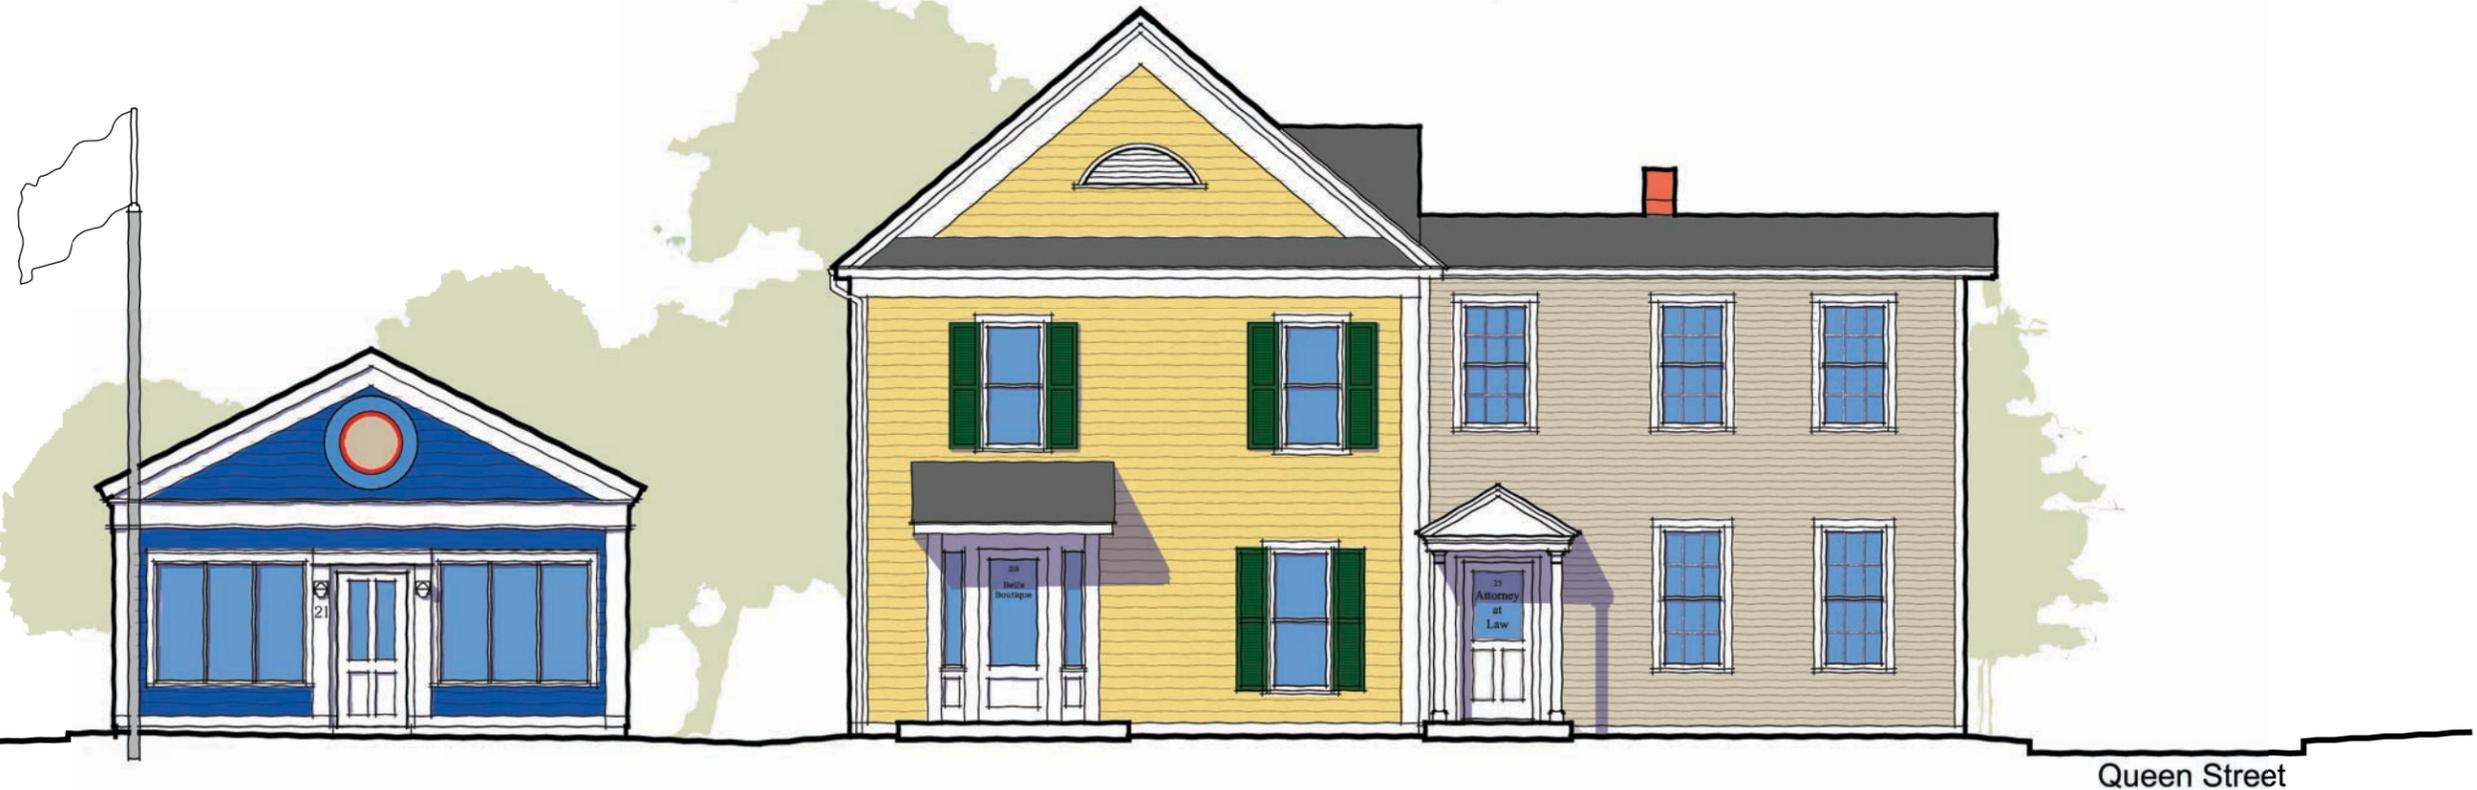
Clinton Street District Revitalization
21 - 25 Clinton Street
Village of Brockport, New York

1. One story, frame building.
2. Front facing gable, moderate slope roof.
3. Simple rectangular plan.
4. Symmetrical three bay facade, center entrance.
5. Horizontal artificial siding.
6. Picture windows.

1. Two story, frame building.
2. Compound roof, moderate slope, with front and side facing gables.
3. Compound plan.
4. Two bays, no entrance this elevation.
5. Horizontal artificial siding.
6. One over one double hung windows.

1. Two story, frame building.
2. Side facing gable.
3. Compound plan.
4. Three bays, with asymmetrical entrance at left.
5. Horizontal artificial siding.
6. Six over six double hung windows.
6. Masonry stoop.

1. Remove artificial siding. Provide narrow wood clapboard siding.
2. Replace glass and subdivide into three sections.
3. Provide wood trim.

1. Remove artificial siding. Provide wood siding and corner boards. Differentiate from 25 with siding width and color.
2. Provide hood and simplified detailing.
3. Add door with fanlite, sidelites and trim.
4. Add vent in gable.
5. Add shutters.
6. Differentiate trim from siding with color.

1. Remove artificial siding. Provide wood siding and corner boards. Differentiate from 23 with siding width and color.
2. Provide Federal Style door hood.
3. Add wood watertable and corner boards.
4. Differentiate trim from siding with color.

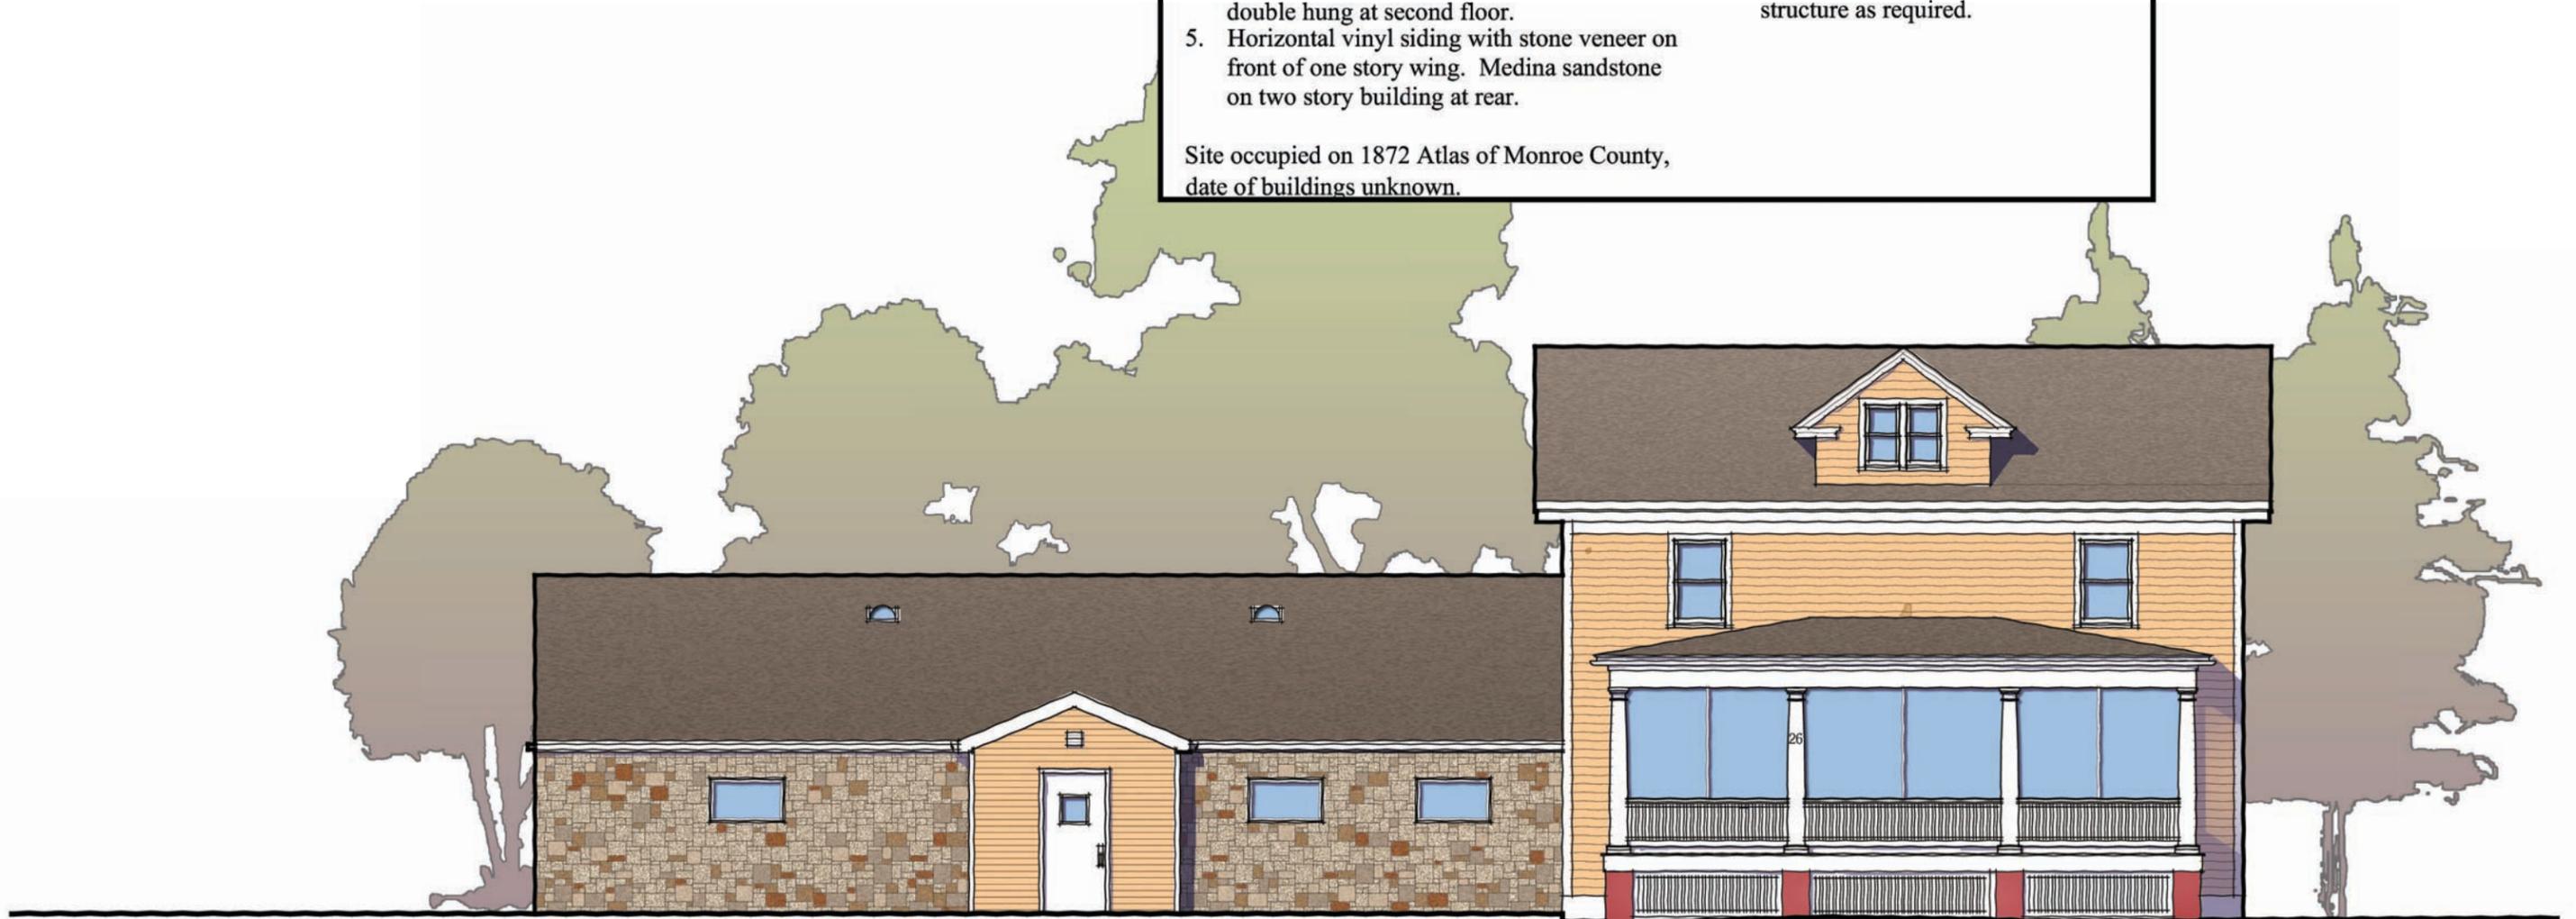
26 Clinton Street

1. Two story frame building, symmetrical front facade with gable roofed dormer. Two story masonry building incorporated into rear of building.
2. Side facing gable, moderate slope roofs.
3. Complex plan.
4. Three bays on primary elevation. Four irregular, asymmetric bays on wing. All windows single lite except one over one double hung at second floor.
5. Horizontal vinyl siding with stone veneer on front of one story wing. Medina sandstone on two story building at rear.

1. Remove vinyl siding and metal cladding on trim. Restore or provide wood siding and trim.
2. Restore porch with wood columns and railing. Add glass infill behind railing to enclose space for business use.
3. Provide one over one double hung windows in dormer.
4. Investigate sag in porch roof, repair structure as required.

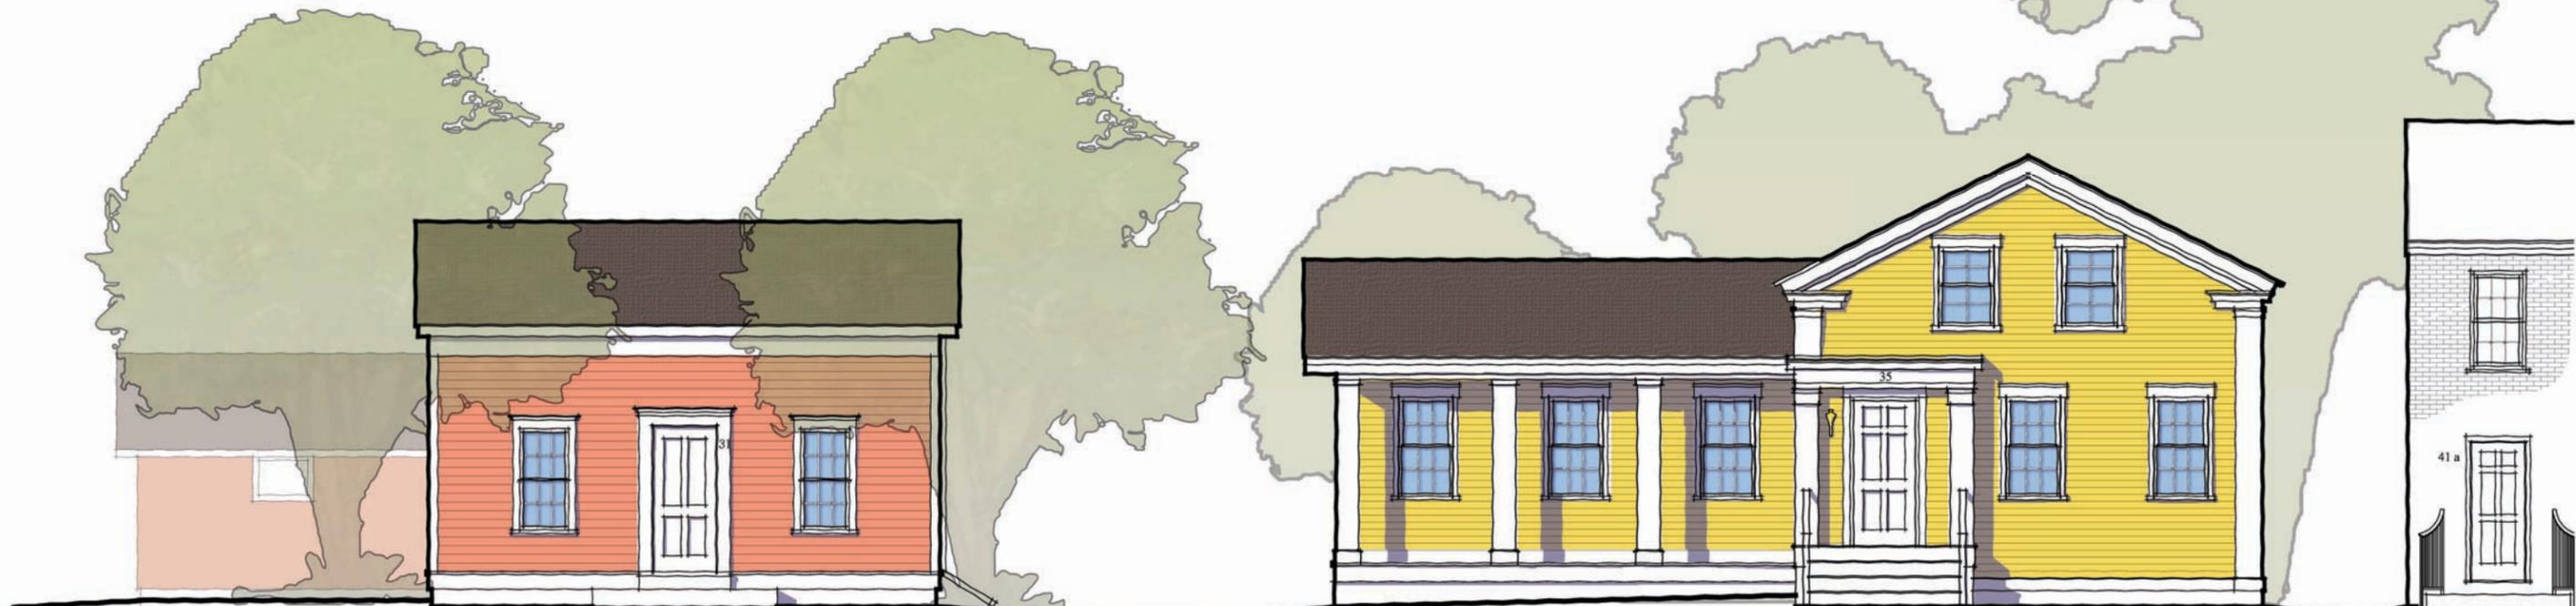
Clinton Street District Revitalization
31 and 35 Clinton Street
Village of Brockport, New York

1. One story, frame building.
2. Front facing gable, moderate slope roof.
3. Simple plan.
4. Three bays, with center entrance.
5. Horizontal siding.
6. One over one double hung windows, frieze band type windows may be added.
7. Masonry stoop.

1. One and one-half story with one story wing frame building.
2. Compound, moderate slope roof with front facing primary gable and side facing gable at wing. Primary gable has eave returns.
3. Compound plan.
4. Six bays at first floor, asymmetrical entrance, irregular two bays at second floor.
5. Horizontal siding.
6. Six over six double hung windows (first floor), six panel door at one and one-half story section, horizontal picture window in one story wing.
7. Covered masonry stoop, simple wooden handrails.

1. Remove modern siding to reveal original style and details.
2. Restore front entry steps.
3. Provide appropriate detailing (Federal Style shown).
4. Provide 6 over 6 double hung windows and four panel door.

1. Remove existing foundation plantings. Provide appropriate landscaping.
2. Remove modern wide siding and metal cladding from trim. Provide narrow clapboard siding, restore exposed wood trim.
3. Restore Greek Revival detailing at projecting front.
4. Provide wooden porch with new railings at existing entrance.
5. Provide porch with beam and columns at one story wing.
6. Provide 6 over 6 double hung windows at one story wing.

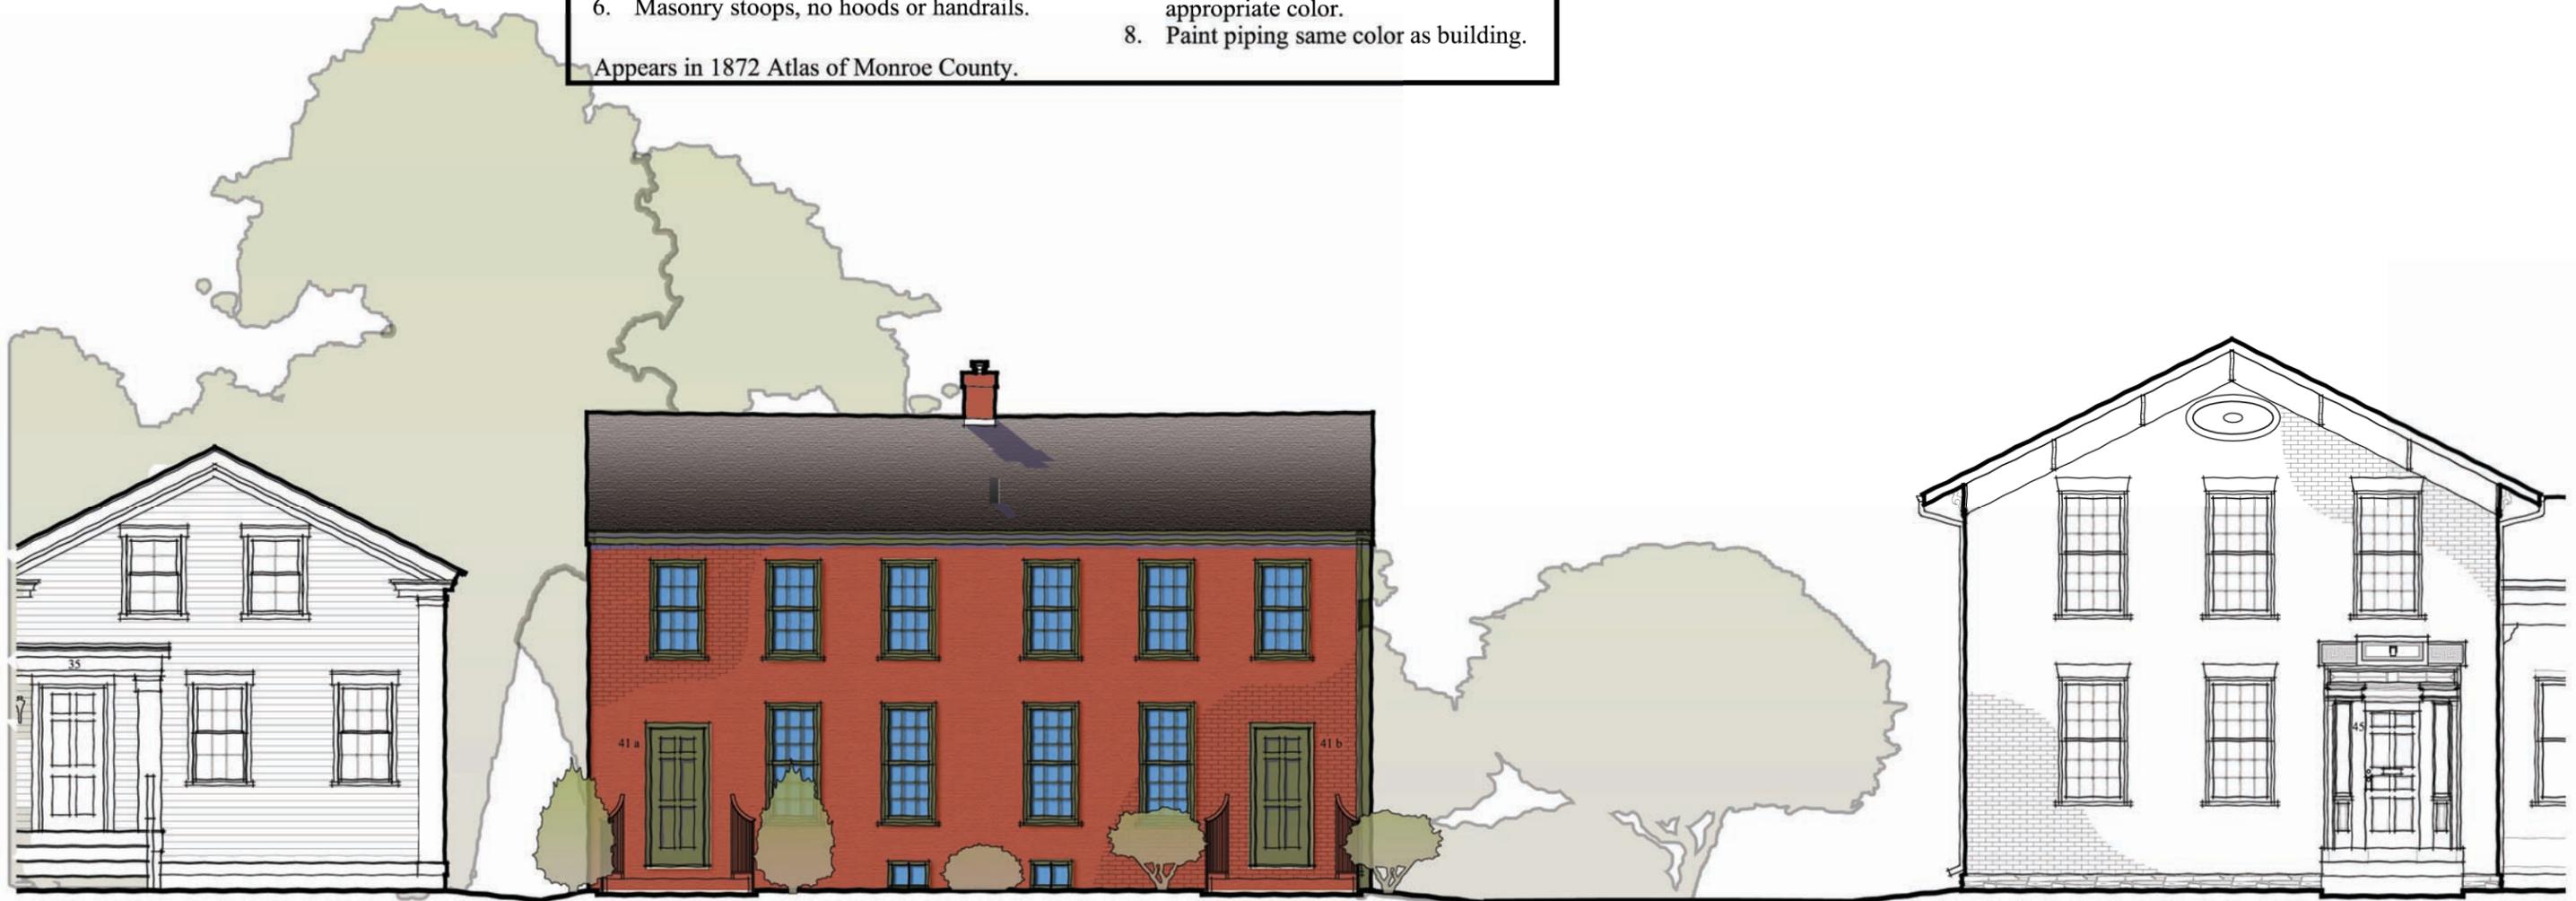
41 Clinton Street

1. Two story brick building.
2. Side facing gable, moderate slope roof.
3. Simple plan.
4. Six bays, symmetrical entrances at outside bays.
5. Nine over nine double hung windows at first floor, six over six double hung windows at second floor. Left hand door has multiple panels with half glass, right hand door is flush.
6. Masonry stoops, no hoods or handrails.

1. Remove vines and foundation plantings.
2. Remove post mounted mail box.
3. Replace roofing with an appropriate color of shingle.
4. Replace left stoop, add metal handrails at both entrances.
5. Paint brick a more subdued color.
6. Replace doors.
7. Paint windows, doors, and trim an appropriate color.
8. Paint piping same color as building.

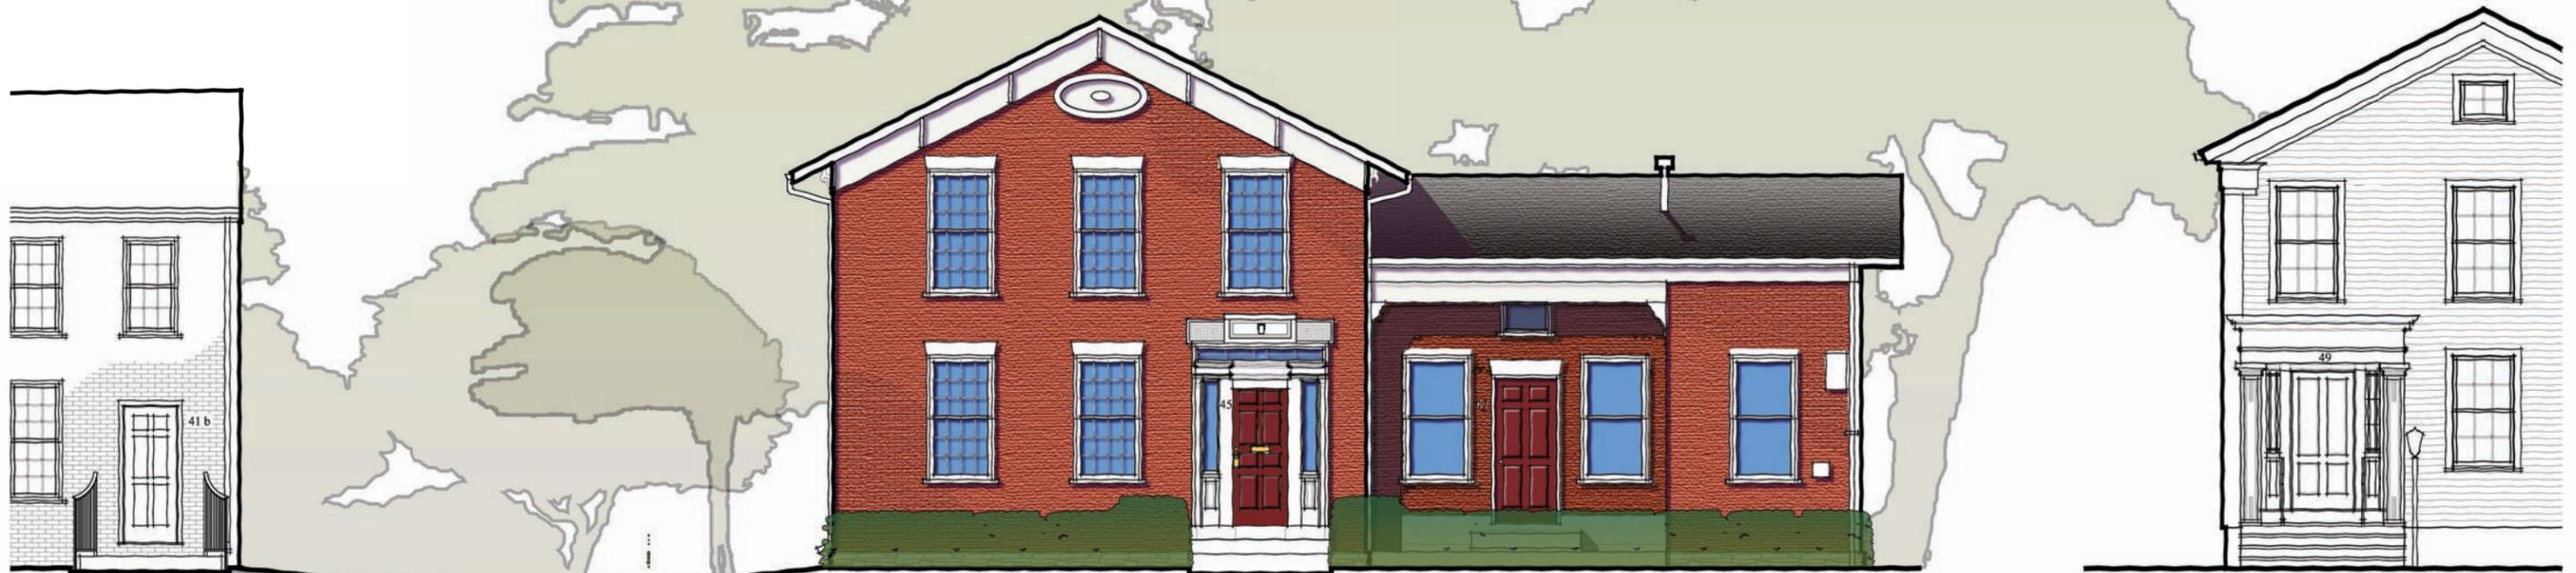
45 - 47 Clinton Street

1. Two story brick building with one story wing. Soldier course flat arches serve as lintels at openings.
2. Front facing gable at primary elevation, side facing gable at wing, moderate slope roof.
3. Three bays, asymmetrical entrance at primary elevation. Four irregular bays at wing.
4. Nine over nine double hung windows at second floor may be original, other windows are one over one. Main entrance is Greek Revival with rectangular transom and sidelites, Greek key fretwork, and paneled door. Paneled door at wing.
5. Masonry stoops, no hoods or handrails.
6. Solid oval gable fanlight.
7. Italianate brackets probably not original.

1. Remove unused (?) chimney at wing porch.
2. Remove skylights at wing roof.
3. Remove foundation plantings. Trim hedge to maximum 24" height.
4. Remove metal cladding on wood trim.
5. Restore window sash to match existing second story windows at gable front.
6. Restore lintel over front door.
7. Paint trim and storm doors and windows an appropriate color.
8. When shingles are replaced, select an appropriate color.
9. Bury overhead utility lines.

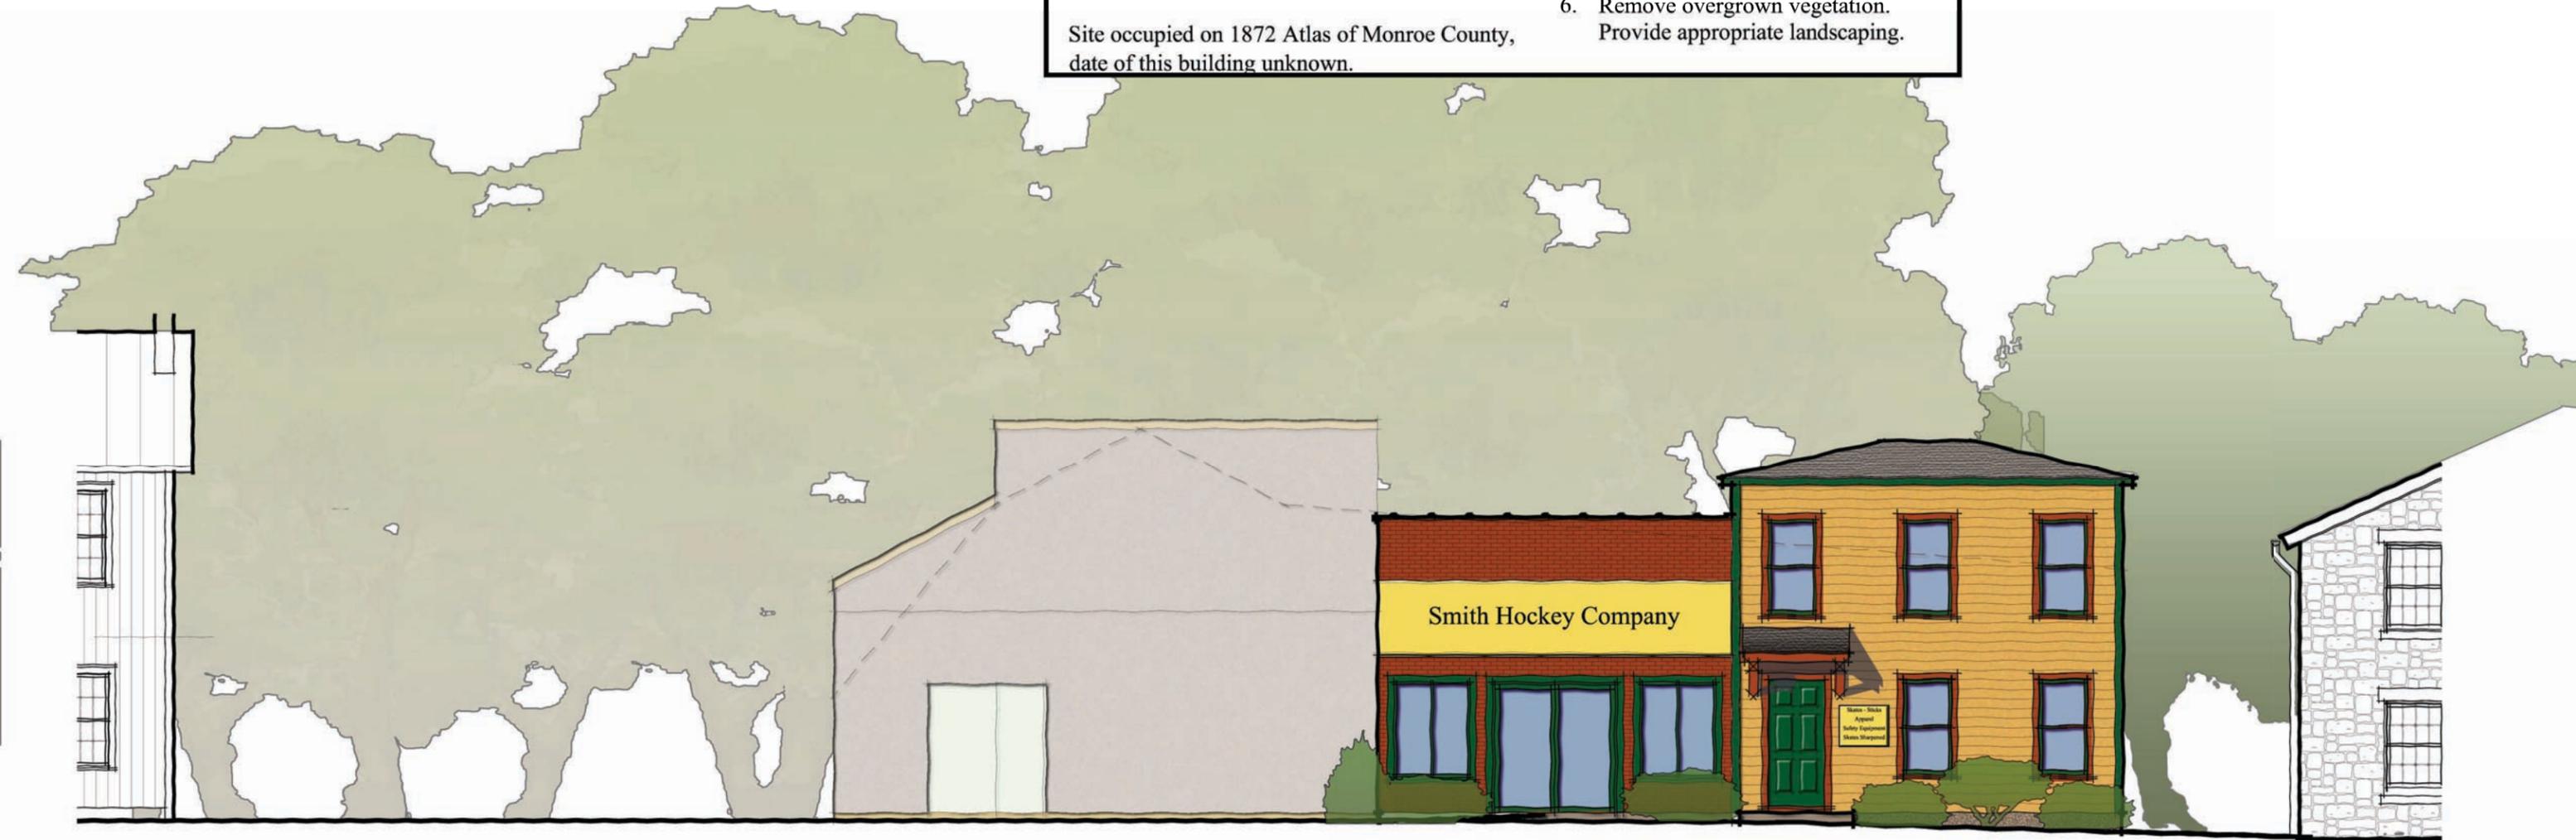
50 Clinton Street

1. Two story frame building with one story wing.
2. Hip roof, moderate slope roof at two story section at front, remainder of front section roof is flat. Rear roofs vary.
3. Compound plan.
4. Single pair modern entry doors only at front elevation.
5. Vertical board siding.
6. Barn at rear.

1. Remove vertical board siding to reveal original style and details.
2. Restore original openings in east side elevation. Provide finish at west side.
3. Provide hood and stoop at east side entrance.
4. Provide entrance door and storefront windows at west side.
5. Remove severely deteriorated barn at rear.
6. Remove overgrown vegetation. Provide appropriate landscaping.

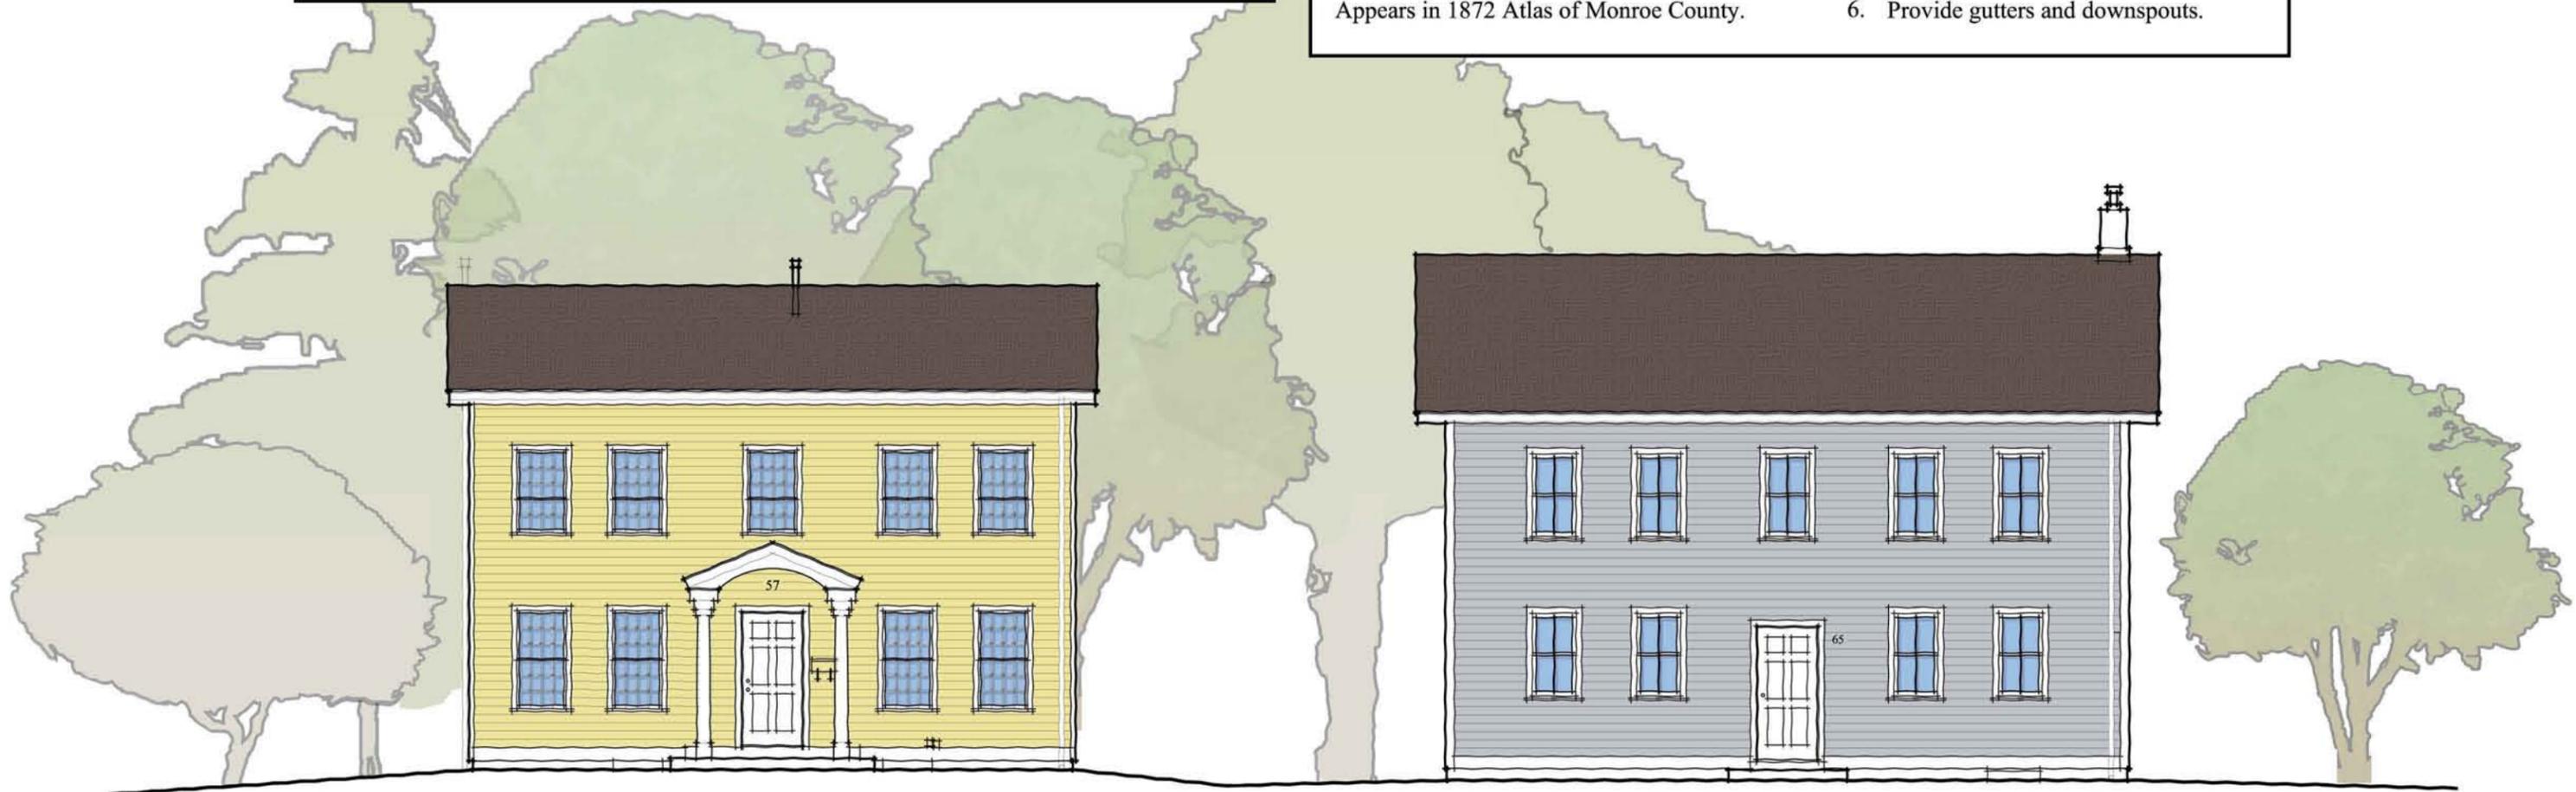
Clinton Street District Revitalization
 57 and 65 Clinton Street
 Village of Brockport, New York

1. Two story frame building.
2. Side facing gable, moderate slope roof.
3. Simple rectangular plan.
4. Five bays, center entrance.
5. Replacement horizontal siding.
6. Variety of double hung window configurations. Twelve over eight second story windows may be original.

1. Two story frame building.
2. Side facing gable, moderate slope roof.
3. Simple rectangular plan.
4. Five bays, center entrance.
5. Replacement faux brick exterior finish, probably roll asphalt.
6. Two over two double hung windows, six panel door.

1. Remove replacement siding to expose original configuration. Restore original wood siding.
2. Remove replacement windows at first floor. Add window to match existing at center of second story, provide twelve over twelve windows similar to second story windows.
3. Provide Federal style details at entry. Add corner boards and water table.
4. Enlarge stoop, improve grade to slope away from house at front.
5. Provide gutters and downspouts.

1. Remove trees close to house.
2. Remove replacement siding to expose original configuration. Restore original wood siding.
3. Repair original wooden windows, provide new storm windows. Add window to match existing at center of second story, provide twelve over twelve windows similar to second story windows.
4. Provide corner boards, watertable, and frieze.
5. Enlarge stoop, improve grade to slope away from house at front.
6. Provide gutters and downspouts.

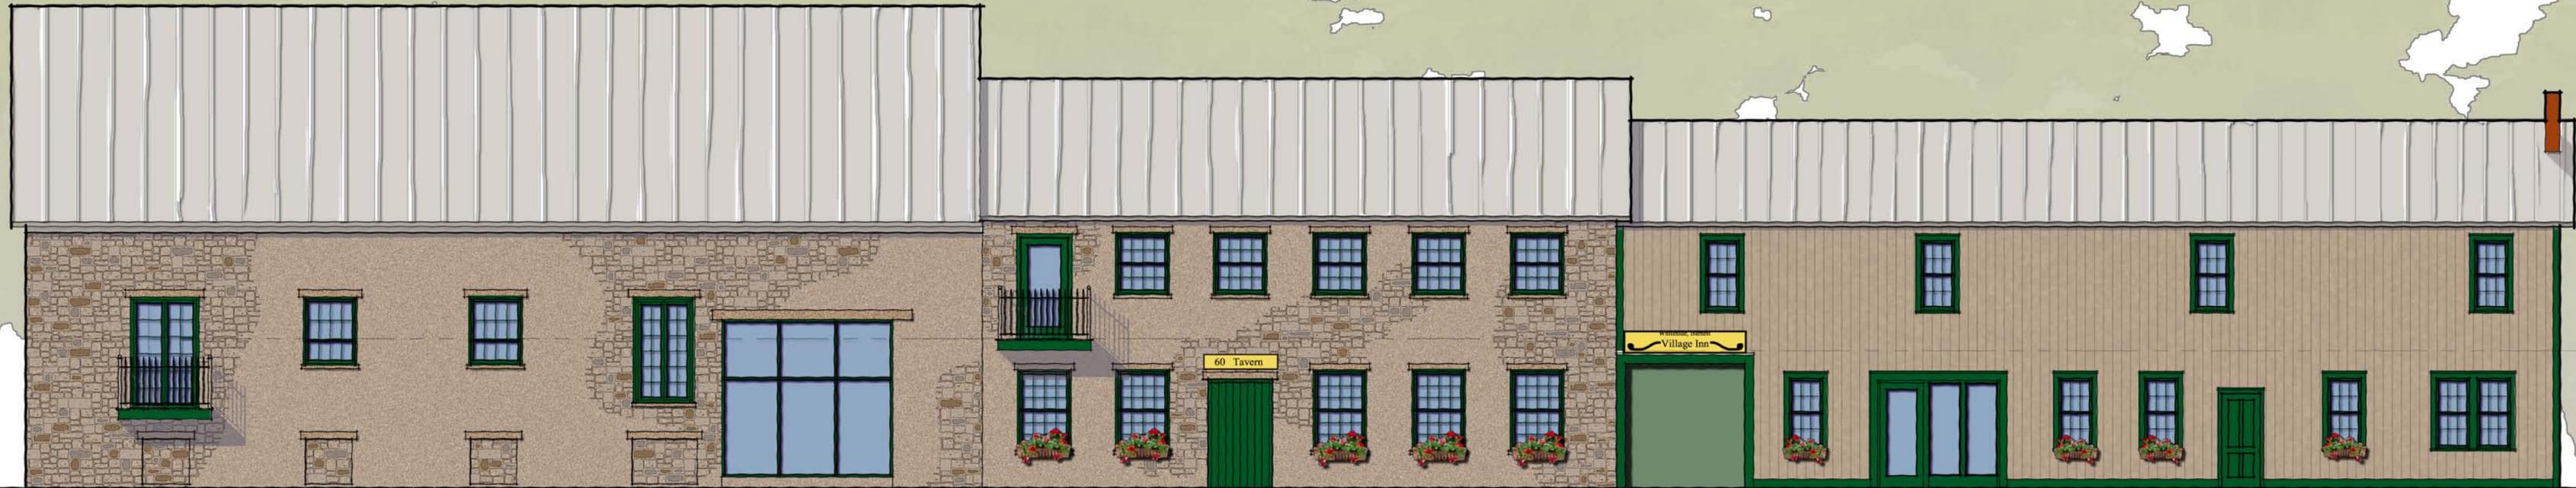
Clinton Street District Revitalization Streetscapes
60 Clinton Street
 Village of Brockport

1. Two story masonry building.
2. Side facing gable, moderate slope roof.
3. Simple plan.
4. Irregular bays.
5. Medina sandstone masonry.
6. Glazing in three left hand openings obscured by protective covers, right hand upper opening single sash, utility opening infilled, possible overhead door.

1. Two story masonry building.
2. Side facing gable, moderate slope roof.
3. Simple plan.
4. Six regular bays.
5. Medina sandstone masonry.
6. Twelve over twelve double hung windows, vertical board doors.

1. Two story frame building.
2. Side facing gable, moderate slope roof.
3. Simple plan.
4. Irregular bays.
5. Modern horizontal siding.
6. Presumed original six over six double hung windows at second floor, modern one over one double hung windows at first floor. One modern passage door, two modern overhead doors at large openings.

1. Repoint masonry at open joints and cracks. Remove existing block and brick infill, provide Medina sandstone to match, recess to retain original openings.
2. Restore existing windows or provide windows to match windows in adjacent section.
3. Replace existing overhead door with windows as shown.
4. Repair roof structure, provide standing seam metal roofing.

1. Repoint masonry at open joints and cracks.
2. Restore existing windows or provide windows to match existing adjacent windows.
3. Replace existing vertical board at grade entry with door to match existing.
4. Replace existing vertical board at second floor with full lite glass door and metal railing.
5. Repair roof structure, provide standing seam metal roofing.

1. Remove horizontal siding to expose vertical barn siding. Provide vertical siding as required.
2. Restore second floor windows. Replace one over one windows with windows to match second floor windows.
3. Replace existing passage door with appropriate door.
4. Replace existing overhead doors with glass doors, solid infill, or windows as shown.
5. Repair roof structure, provide standing seam metal roofing.

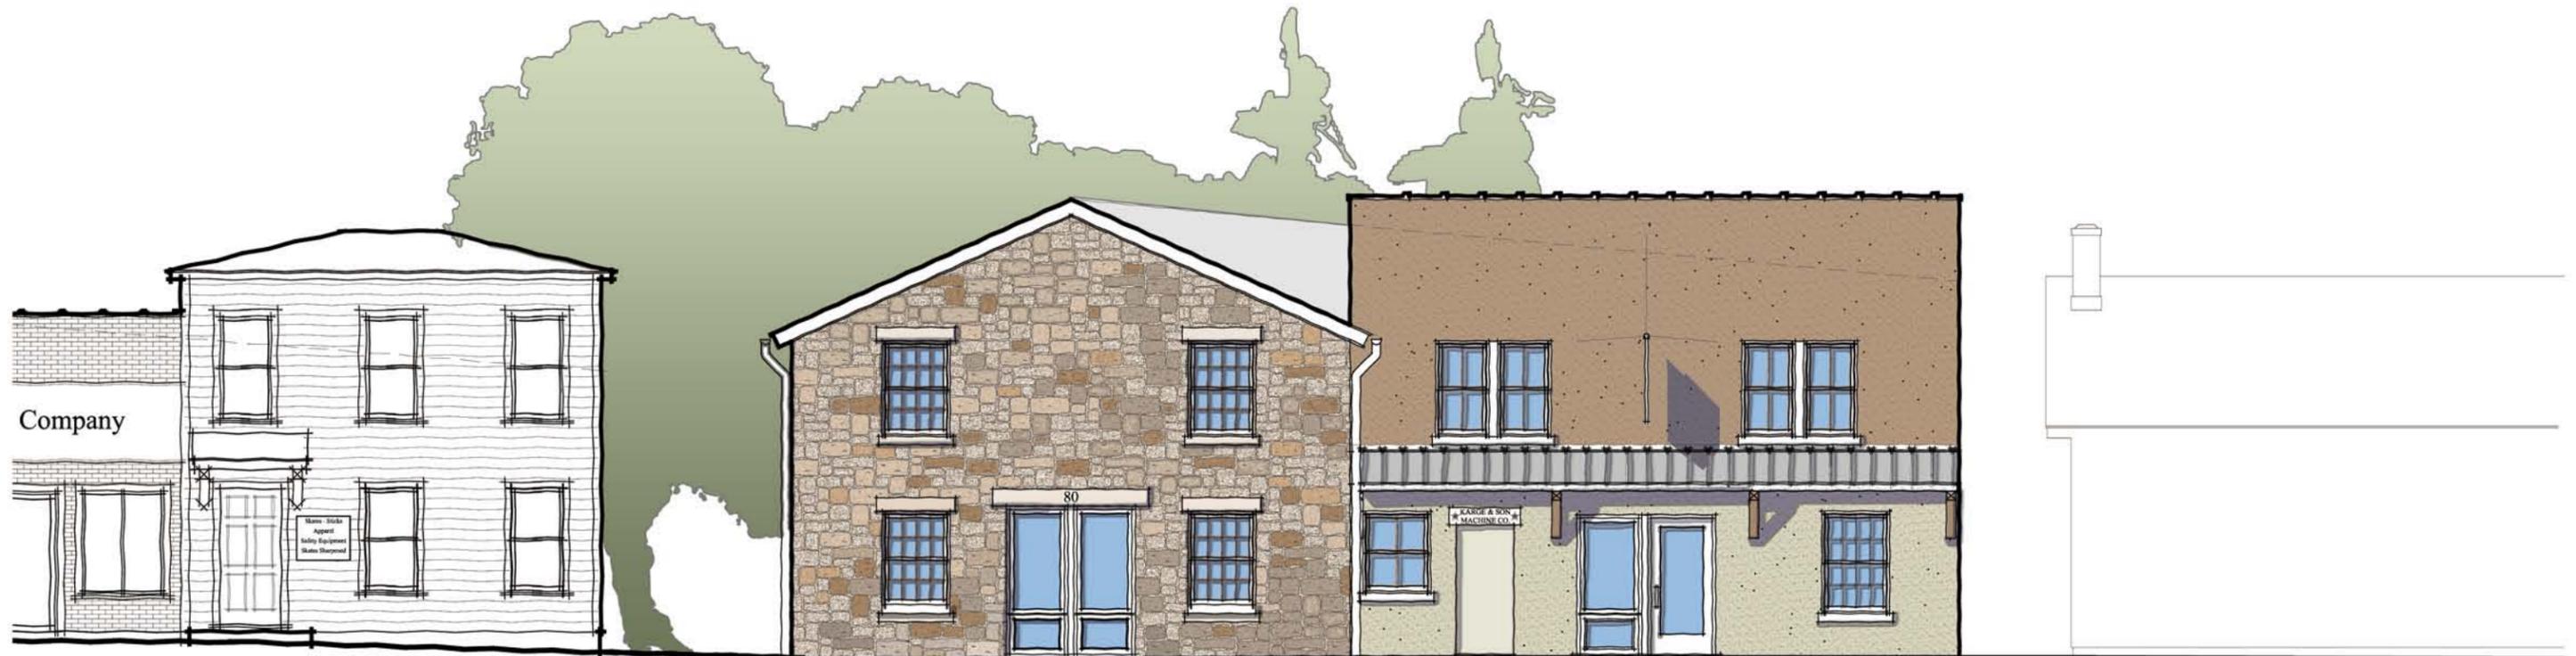
80 Clinton Street

1. Two story masonry building.
2. Parapet on front elevation suggests flat roof. Actual - west side is front facing gable, moderate slope with low slope roof runs to east of ridge.
3. Simple plan.
4. West side, three bays. East side irregular bays. Windows on west are eight over eight, windows on east are mix of single pane, two over two, and eight over eight.
5. Stucco finish applied to unify front elevation. Rear of west side shows Medina sandstone construction.

1. Remove false parapet, restore eaves.
2. Remove stucco finish. Repair and repoint stone masonry as required.
3. Replace windows with entry doors at center opening.

1. Reconfigure roof at meeting of two buildings.
2. Add canopy with metal roof.
3. Replace entry doors with new door and storefront windows.
4. Repair stucco finish.
